BearingsPlus
A Waukesha Bearings Business

Fluid Film Bearing Damage

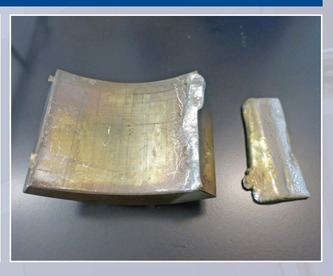
Excessive Bearing Temperatures

Coking of Oil on Surface
Oxidation of oil resulting in plating at the hot spot; also check for electrostatic discharge damage

Creep
Combination of high temperature and high load causes whitemetal lining to deform

Melted Lining
Heat soak through the housing melts the whitemetal lining

Potential Solutions
- Adjust operating conditions to lower the temperature
- Use copper chromium (CuCr) backing to remove heat more quickly
- Use 'Directed Lubrication' to reduce heating
- Change to offset pivot to increase cool oil flow through pad
- Assess bearing alignment
- Check for electrostatic discharge
- Check the bearing load
- Use a lining material with higher temperature capability; below are standard maximum temperatures
  - Whitemetal: 130°C (266°F)
  - Aluminum tin (AlSn): 160°C (320°F)
  - Polymer: 250°C (482°F)
- Maintain post-lubrication flow

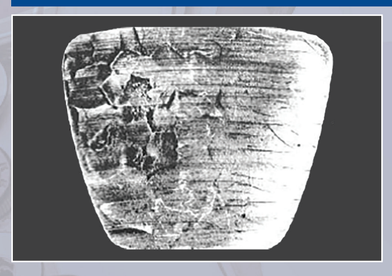
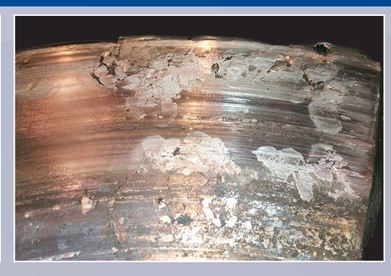
Thermal or Mechanical Fatigue

Thermal Faceting
Unique to tin-based whitemetal; caused by differential expansion in the tin's grain axes; typically not detrimental, but prolonged and severe faceting can lead to cracking

Intergranular Cracking
Cracking and pullout of whitemetal grains; a thin layer of whitemetal may remain, or in the case of poor bonding, bare steel may be exposed

Potential Solutions
- Investigate reasons for regular changes to load or temperature (e.g., repeated start-up and shutdown, dynamic misalignment, liquid slugs)
- Analyze whitemetal composition and microstructure
- Use a lining material with greater fatigue strength, such as AlSn or polymer

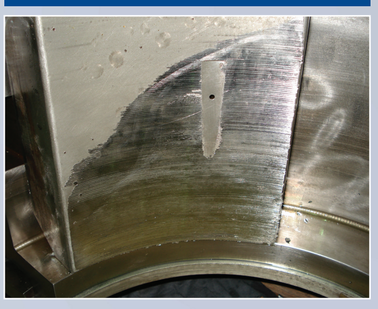
Static Misalignment

Uneven Wear
Angled damage, unevenly distributed across the bearing

Potential Solutions
- Correct the machine's alignment
- Use a bearing with greater misalignment capability (e.g., tilt pad bearing, ball and socket pivot)

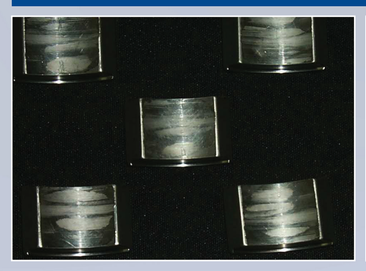
Rotating Load or Dynamic Misalignment

Polish
Characterized by polish across all bearing pads; can lead to intergranular cracking and wiping

Pivot Wear
Shaft orbiting in the bearing clearance results in pivot marking on each pad

Potential Solutions
- Take steps to reduce the rotating load
- Align thrust collar to shaft
- Consider using ISFD® technology – an integral squeeze film damper – to improve rotordynamics
- Consider using a Flexure Pivot® bearing to reduce pivot wear

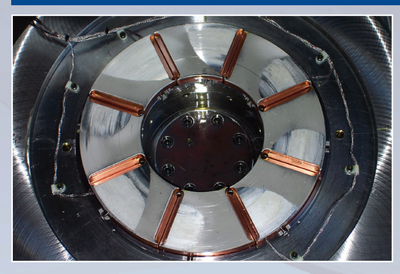
Overloading

Wiping
Excessive operating load ruptures film, resulting in contact between bearing and collar

Wiping
On tilt pads, wiping caused by overloading is typically seen in conjunction with pivot deformation

Pivot Wear
Can result in increased clearance, leading to vibration

Potential Solutions
- Reduce load
- Investigate and address causes of dynamic loading
- Check that the hydrostatic jacking system is operating properly
- Increase bearing size to increase load capacity
- Reduce pivot contact stress with Flexure Pivot® bearings or ball and socket pivot

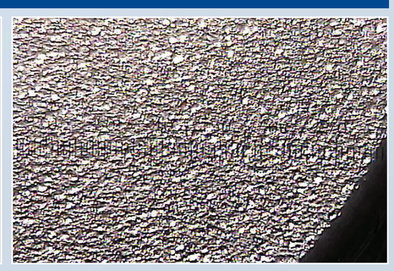
Electrostatic Discharge

Frosting
Discharge on right side of pad shows typical "frosting"

Pitting
A magnification of the "frosting" shows pitting

Potential Solutions
- Investigate the grounding of the rotor and insulation at each bearing
- Replace metallic pads with polymer-lined pads for polymer's insulating properties
- Install Inpro/Seal® Smart™ CDR® technology
